FIELD EVALUATION OF NDT DEVICES FOR DELAMINATION DETECTION OF HMA
AIRPORT PAVEMENTS

PRESENTED FOR THE
2014 FAA WORLDWIDE AIRPORT TECHNOLOGY TRANSFER CONFERENCE
Galloway, New Jersey, USA

August 2014

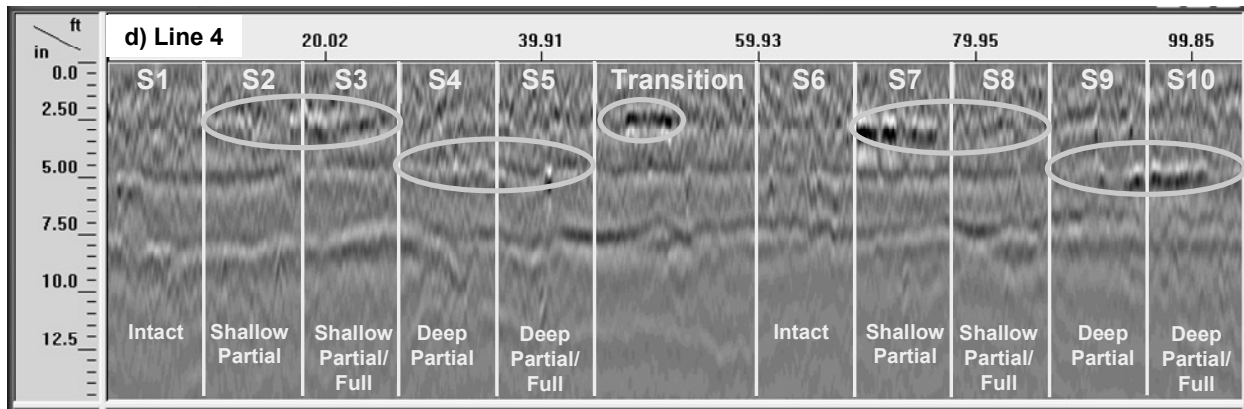
Figure 4. Ground-Coupled GPR Linescans along a Line with Prepared Debonding.

Typical GPR linescans along a line containing debonded areas and locations of the prepared debonding are shown in Figure 4. GPR detected the severely debonded area and some debonded areas. This is noted as stronger (darker) reflections at the layer interfaces. It was found that GPR may be most suitable when the debonding is in severe stages or moisture is present along the interface of the debonded layers.

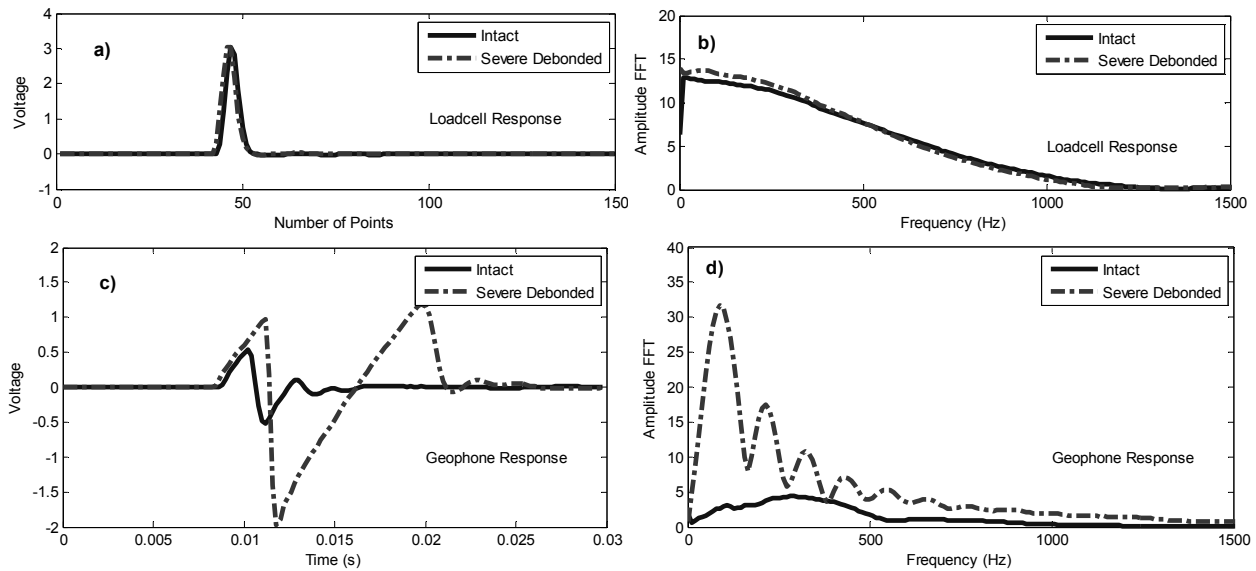
Figure 5. Time Records and FFT Results from IR Examples on Small Scale Study.

IR test results on a sound and severely debonded area are shown in Figure 5. The voltage amplitude of the geophone for the severe debonded area was around three to four times as large as compared to the intact location and also much wider, while the amplitude of the load remained similar (see Figures 5a and 5c). The ratio between the load cell and geophone amplitudes can be used initially because of its simplicity where smaller ratio corresponds to greater flexibility of the section and therefore debonded locations. A more appropriate analysis consisted of determining the frequency responses using a Fast-Fourier Transform (FFT) algorithm (see Figures 5b and 5d). For the intact location the amplitude presented a dominant frequency of 300 Hz with amplitude of 4.5 and for the severe debonded the frequency was erratic and the maximum amplitude was close to 30. The ratio of the maximum values of the FFT amplitudes (stiffness) was used to compare the results. Based on the studies conducted on the constructed section, the IR method seemed promising for the detection of the fully-debonded areas both shallow and deep and some of the partially-debonded areas.

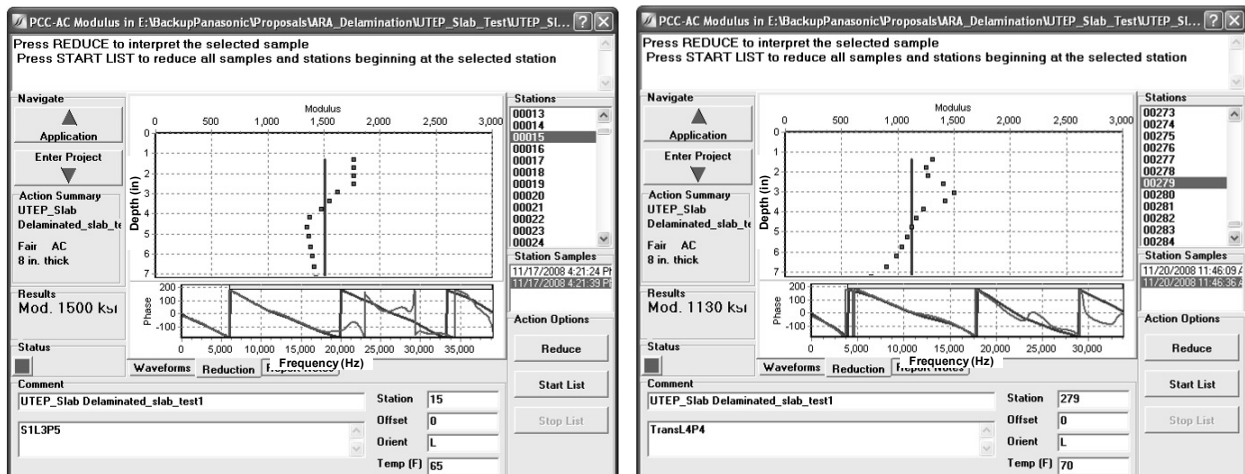
Figure 6. Dispersion Curve Results with PSPA.

The PSPA USW analysis pages as seen by the operator in the field are shown in Figure 6 for the intact and severely debonded locations. The graphs demonstrate the variation in modulus with wavelength (called dispersion curves). The dispersion curve for the intact area is fairly uniform; whereas for the damaged point a sharp decrease in modulus below a wavelength of 2.5 in. (63 mm, the location of the damage) is evident. The vertical red lines in the graphs demonstrate the average moduli of the HMA layer from close to surface (1 in., 25 mm) to 8 in. (200 mm, nominal thickness of the layer). As reflected in the left hand side of the two graphs, the average moduli are about 1500 ksi (10 GPa) for the intact and 1130 ksi (7.8 GPa) for the severely-debonded areas. Since HMA modulus is temperature dependent, the values presented were converted to a reference temperature of 77°F using (Li and Nazarian, [12]). From the controlled section investigation, it was found that the USW method might be able to identify delaminated areas reasonably well, especially the shallow ones.

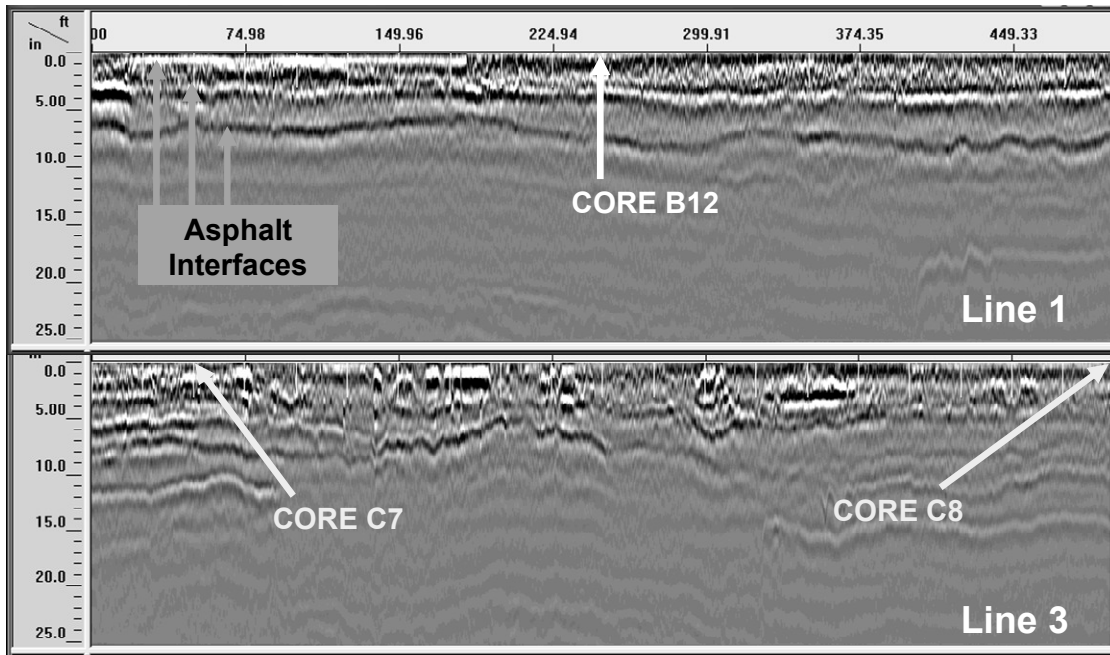
Figure 10. NDT Results on Section A5.

Ultrasonic surface waves, impulse response, ground-coupled GPR and FWD were used to investigate these sections. Three or four 200- to 500-ft long lines were selected at each site. The GPR tests were carried out along these lines. The other tests were carried out at discrete points between 20 ft. to 50 ft. apart to maximize data coverage. Post-processed GPR linescans along lines 1 and 3 at this section are shown on Figure 10a. Several HMA layer interfaces are

identified. Some of these interfaces showed stronger reflections that might indicate the presence of trapped moisture or the existence of stripping or debonding, particularly for the first 200 ft. The results from the other NDT methods are also shown in Figures 10b, 10c and 10d. All methods and analyses point to problems along Line 3. Table 1 contains the results of the four confirmatory cores extracted from this section. The results from the three mechanical tests (i.e., PSPA, IR, FWD) are similar for cores B11, B12 and point to intact sections. Even though the mechanical tests for the other two cores indicate damaged cores, the cores were reasonably intact without any indication of debonding. However, the quality of HMA was in question.

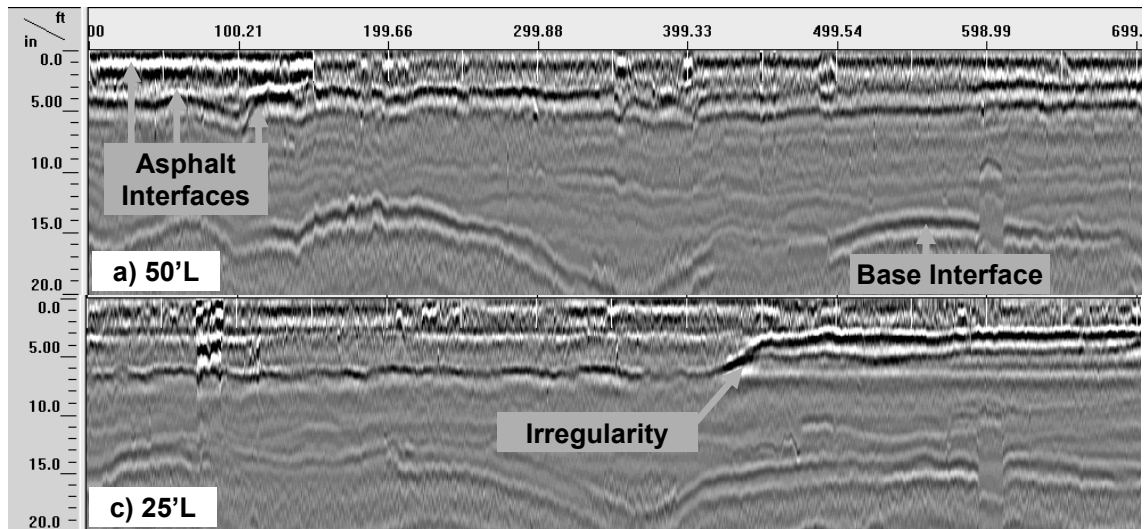
Figure 13. Post-processed GPR Linescans and other NDT Results on Section 1 of BOS.

Post-processed GPR linescans are shown in Figure 13a. Only two of the seven lines are shown for reference (see Celaya et al. [11] for more details). Several horizontal lines associated with the HMA interfaces are marked. Three HMA lifts are observed on all lines at depths of about 2 in., 4 in. and 6 in. Some of these interfaces show strong reflections that might indicate the presence of trapped moisture, stripping or debonding. In addition, some irregularities were identified. The PSPA and IR results are also illustrated in Figure 13 for the seven lines of Section 1. Based on both methods, the worst conditions are observed mostly about the centerline. Most of the points on these lines were identified as marginal or damaged. Dispersion curves from PSPA tests showed stronger reduction in modulus for points about the centerline of the runway.

The conditions of the five cores previously retrieved are compared with the interpretation of the results from NDT devices in Table 2. The conditions of Cores C-15 (intact core) and C-18 (debonded core at 3 in.) as shown in Figure 14 correlated well with the results with the PSPA and IR method. Some discrepancy was found on core C-17 (debonded at 6 in. depth), since PSPA showed marginal condition and IR intact condition, respectively.
